Technical Bulletin

Model
928, 928S

Subject: Modified Lower Ball Joint Support and Mounting

Number
84-01

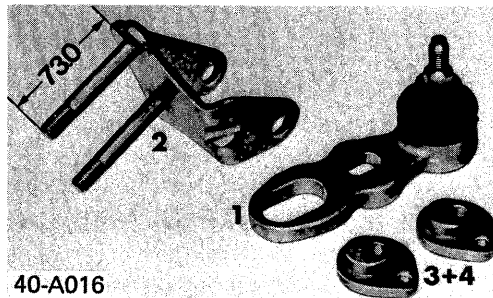
Fig. 1 New version

1. ball joint support
2. mounting bracket
- 3/4. caster/camber eccentrics

Caster/camber holes in ball joint support have been switched. Caster is now adjusted with the inner eccentric and camber with the outer.

New and old version component pieces may **not** be interchanged.

New version parts may be installed on one or both sides of an earlier vehicle, but initial installation requires use of following parts (see Fig. 1 and 2):

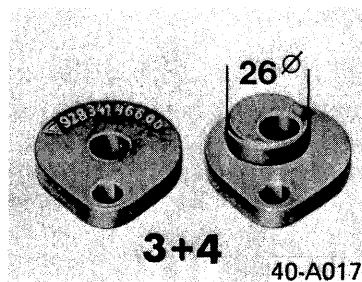
Fig. 2 Caster/camber adjusting eccentrics, new version

- New version eccentrics are identical and are stamped with the new part number

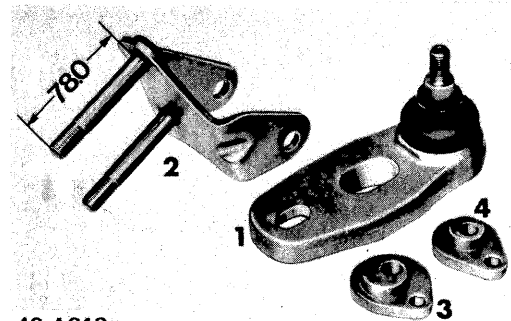
Fig. 3 Previous version

1. ball joint support
2. mounting bracket
3. camber eccentric
4. caster eccentric
