Some background may be helpful on the symptoms I observed before diagnosing the problem. One day, while my wife was driving Virginia, she pressed the A/C button on the center console but no cold air came out. She promptly reported the problem to me, her favorite full-time 928 mechanic. I had replaced the compressor with a new rebuilt unit very recently and fully recharged the system so thought I must have done something wrong. I noticed the cooling fans engaging right on queue when the A/C button was pressed. This initially gave a Newb like me a false sense of security as I assumed the compressor was also engaging.

CONGRATULATIONS! You've completed the HVAC compressor relay repair and should be able to enjoy cold air once again!!

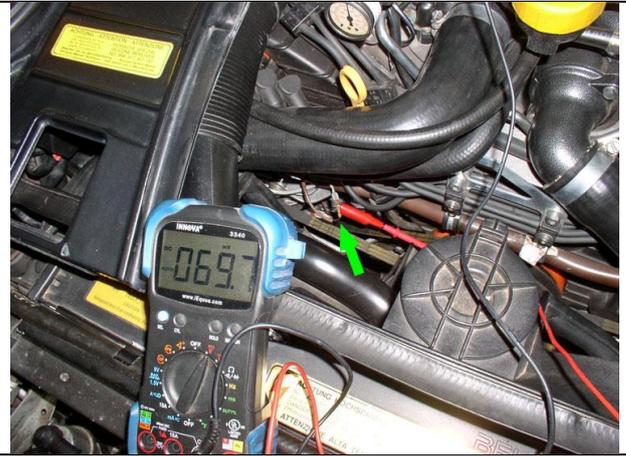
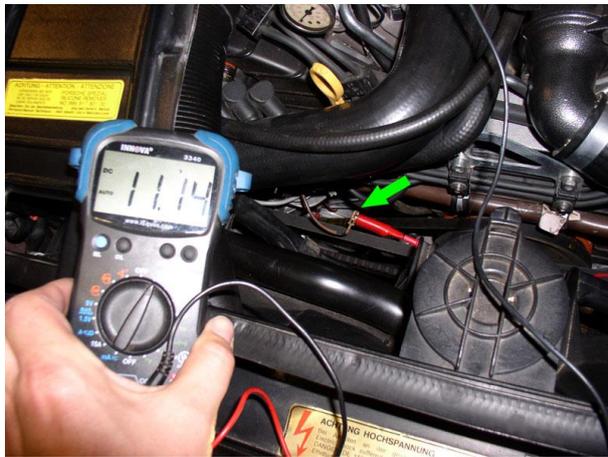
The first step in the troubleshooting was to determine if voltage was getting to the compressor. I removed the protective plastic casing where the compressor lead connected to the power lead so I could get good access to the leads for testing. When I depressed the A/C button on the center console, I only received 69.7 mVolts. This seemed strange but explained why the magnetic clutch was not engaging. I should be receiving battery voltage at this connection.

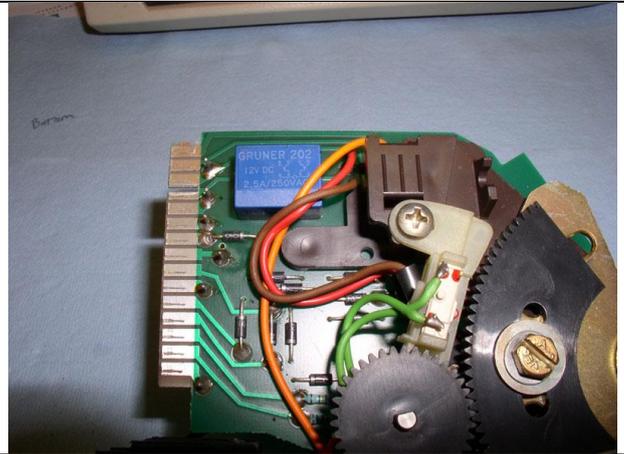
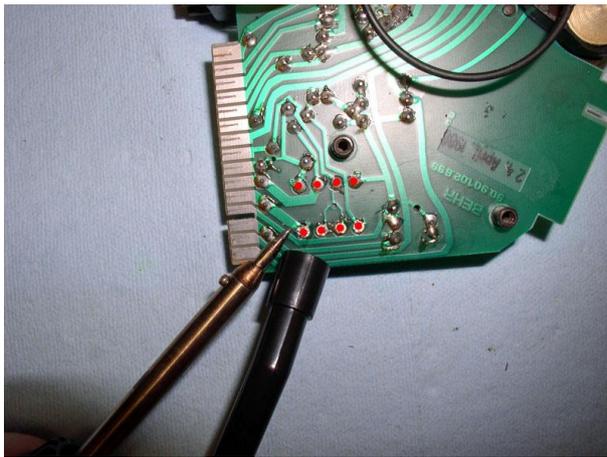
On the top side of the unit, I found the faulty relay. It was colored blue for my unit. The top of the relay has the schematic and spec ratings. It's a 12 volt relay rated for 2.5 amps. I understand from Louis Ott's addition to Dr Bob's write up that the compressor is expected to draw about 3.5 amps at 13.5 volts so it should not be a surprise for these relays to fail.

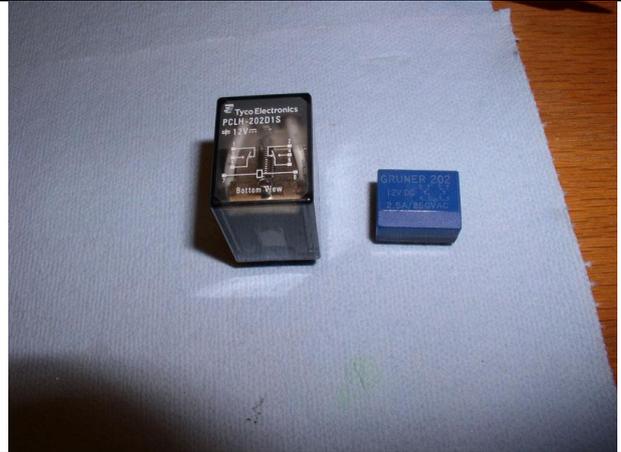
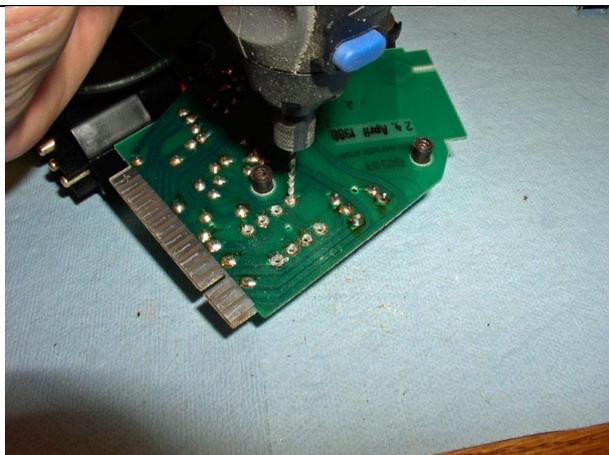
Here is a comparison of the two relays. You can see the new relay is substantially beefier than the original relay.

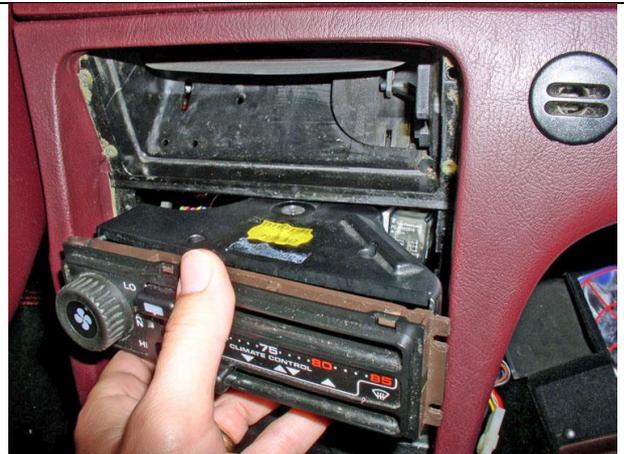
Begin positioning the head unit into the center console. Since the new relay was installed level with the head unit casing, I had no trouble sliding the unit in. Before fully installing the unit, I couldn't wait to test it first and see if it was going to work. So I turned the key on but did not start the engine and pressed the A/C button with the lower slider not in the "off" position. I could hear and actually see the relay operate. I then checked the clutch at the compressor – ENGAGED! It worked!!

Now the head unit is ready to be re-installed in the center console. First, connect both wiring harnesses to the left side of the control unit as depicted below.

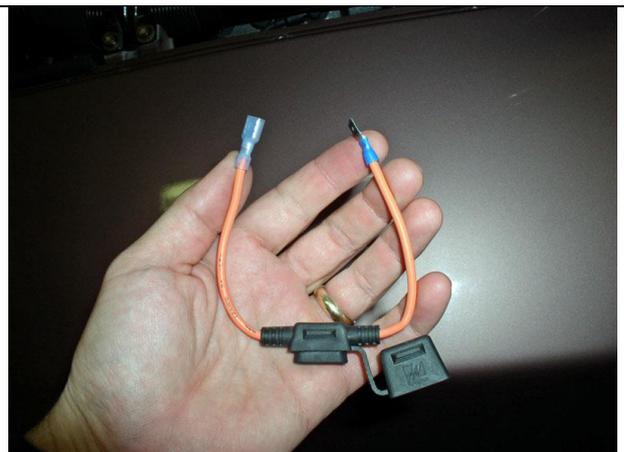
Since we replaced the smaller relay with a much beefier one rated at 10A which is much higher than the original 2.5A relay and the fact that the A/C compressor coil circuit is unfused between the HVAC head unit and the compressor, we must insert an inline fuse. The inline fuse will prevent circuit overload and the possibility of fire. The fuse will be inserted on the power line going into the freeze switch (this is a direct line from the HVAC head unit from the new relay). The recommended amperage of the inline fuse is 3A. I'd like to thank Greg Brown (GregBBRD on Rennlist) for this important addition and added protection from possible fire –
THANKS, Greg!

I purchased a standard, already wired inline fuse from O'Reilly's Auto Parts Store that had a cover. It was about \$4. I put a 1/4" male spade connector on one end of the wire and a 1/4" female protected spade connector on the other end and crimped them into place as shown in the pic below.
