Some background may be helpful on the symptoms I observed before diagnosing the problem. One day, while my wife was driving Virginia, she pressed the A/C button on the center console but no cold air came out. She promptly reported the problem to me, her favorite full-time 928 mechanic. I had replaced the compressor with a new rebuilt unit very recently and fully recharged the system so thought I must have done something wrong. I noticed the cooling fans engaging right on queue when the A/C button was pressed. This initially gave a Newb like me a false sense of security as I assumed the compressor was also engaging.

CONGRATULATIONS! You've completed the HVAC compressor relay repair and should be able to enjoy cold air once again!!

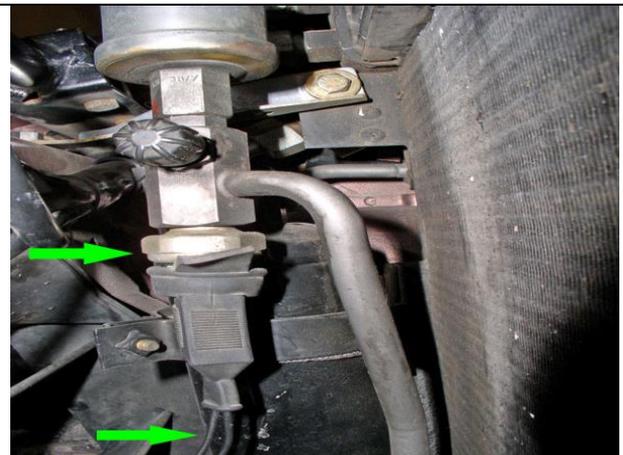
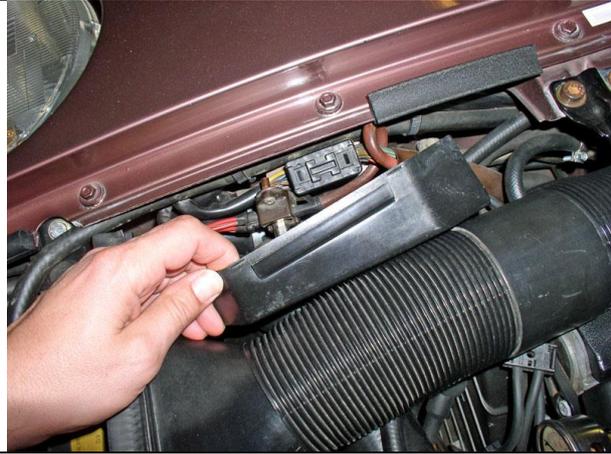
The next component down the voltage line to the compressor is the refrigerant Low Pressure Switch. It has one wire coming in and one wire going out. It simply monitors the pressure in the AC system and if the pressure is below the safe minimum, it opens the circuit which cuts power to the compressor. This preserves the compressor and helps prevent compressor damage from an inadequately charged system. The pressure switch is located underneath the high pressure port at the front of the condenser and is depicted by the upper green arrow below.

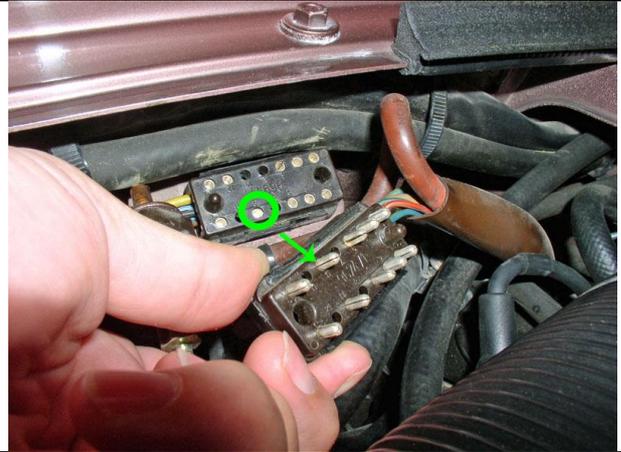
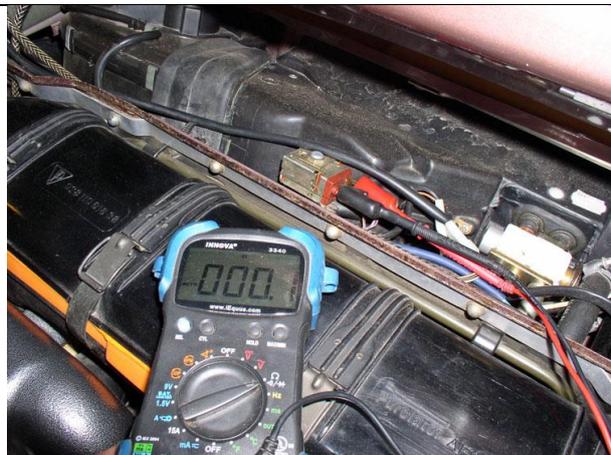
The final item worth checking in the line up to the compressor is the infamous 14-pin engine harness connector located at the battery post in the engine compartment. Remove the plastic cover and you'll see the top of the black connector as seen below.

Power passes to the compressor through pin #9 in the connector. The female side is bringing voltage from the Low Pressure switch while the male side of the connector carries voltage directly to the compressor.

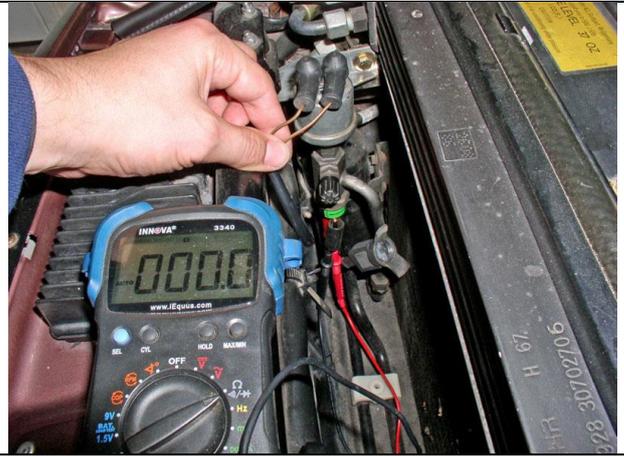
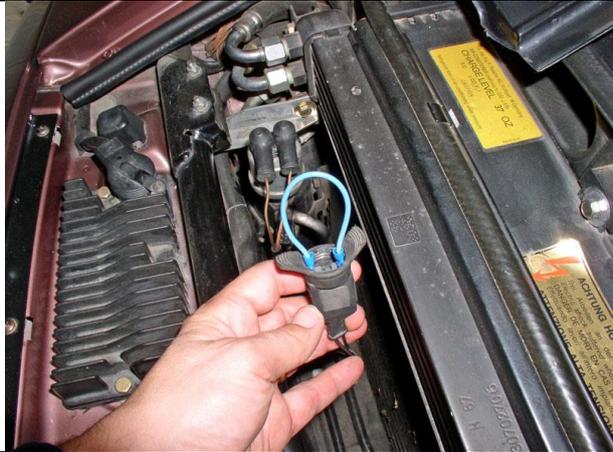
Knowing the system was fully charged, I tested the Low Pressure Switch for continuity. When the system has greater than the minimum pressure in it, the circuit in the switch should be closed and voltage should pass through. With the multi-meter, I took a reading on the two switch connectors as indicated below and received 0.0 Ohms reading indicating expected performance from the Low Pressure Switch.

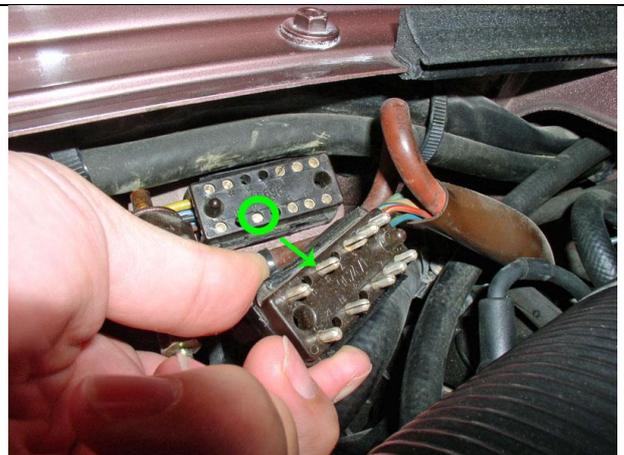
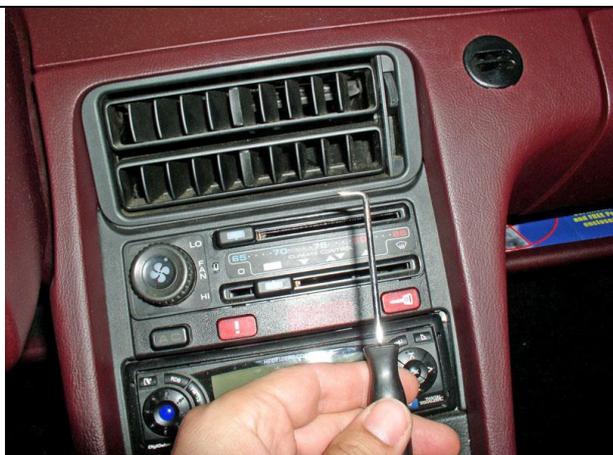
Lastly, I tested the 14-pin wiring harness for expected voltage. With the A/C switch depressed and the lower slider knob not in the "off" position, I received battery voltage at the female side of pin #9 as expected. I inspected both male and female connectors and they were clean. I applied battery voltage from the battery post to the male pin #9 and the compressor clutch engaged. I surmised that the 14-pin connector was not contributing to the compressor voltage problem.

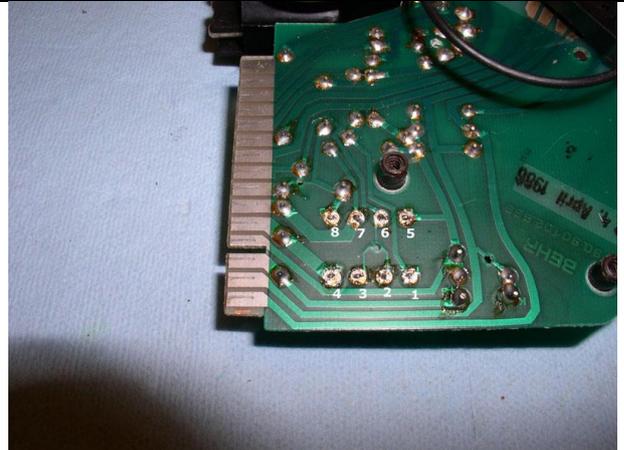
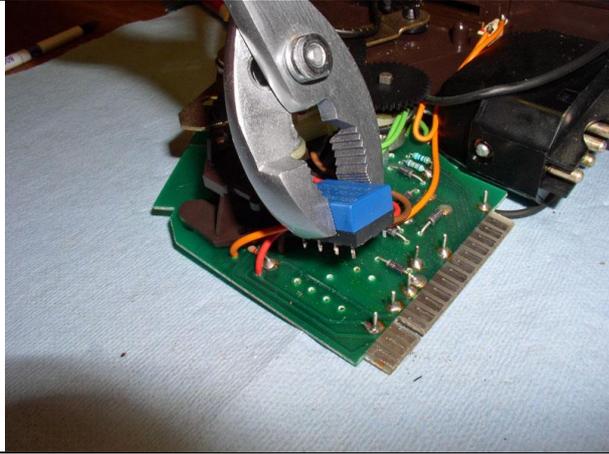
When all the joints have been desoldered, it should look something like the picture below. My eyesight isn't what it used to be (getting older is a bummer!) so I used a magnifying glass to closely inspect each pin to make sure the pins were free of remaining solder. Once the solder is removed, you may notice the pins are numbered (pins 1, 4, 5, and 8 on the PC board). The pin numbers are annotated in the pic below for clarity.

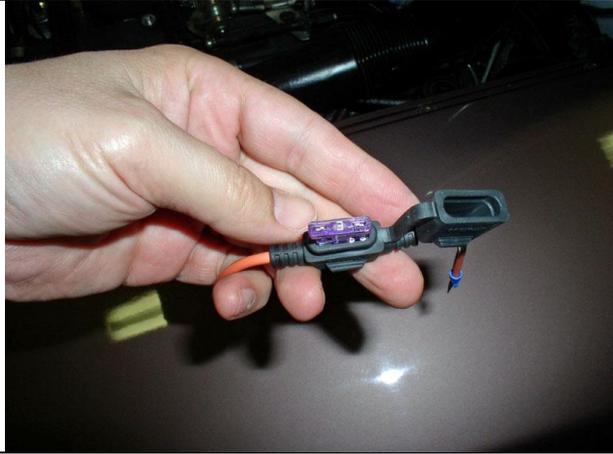
Since we replaced the smaller relay with a much beefier one rated at 10A which is much higher than the original 2.5A relay and the fact that the A/C compressor coil circuit is unfused between the HVAC head unit and the compressor, we must insert an inline fuse. The inline fuse will prevent circuit overload and the possibility of fire. The fuse will be inserted on the power line going into the freeze switch (this is a direct line from the HVAC head unit from the new relay). The recommended amperage of the inline fuse is 3A. I'd like to thank Greg Brown (GregBBRD on Rennlist) for this important addition and added protection from possible fire –
THANKS, Greg!

I purchased a standard, already wired inline fuse from O'Reilly's Auto Parts Store that had a cover. It was about \$4. I put a 1/4" male spade connector on one end of the wire and a 1/4" female protected spade connector on the other end and crimped them into place as shown in the pic below.

I inserted a standard 3A fuse.
